SERVICE BULLETIN NUMBER 2

GEAR SETTING AND ADJUSTMENT

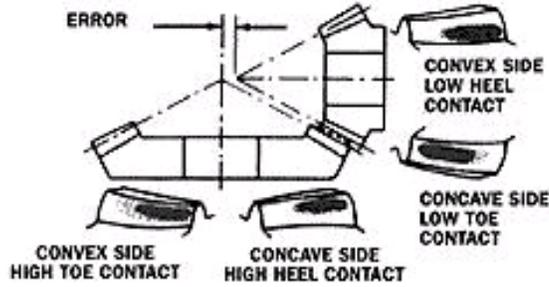
PROFILE ERROR

To correct: decrease mounting distance

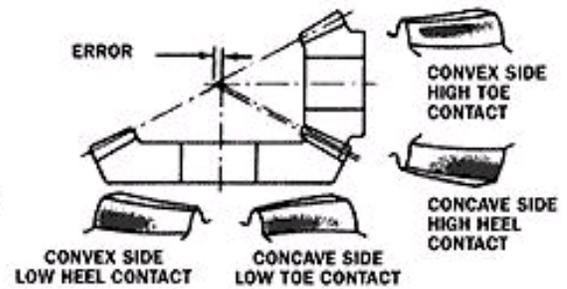
PROFILE ERROR

To correct: increase mounting distance

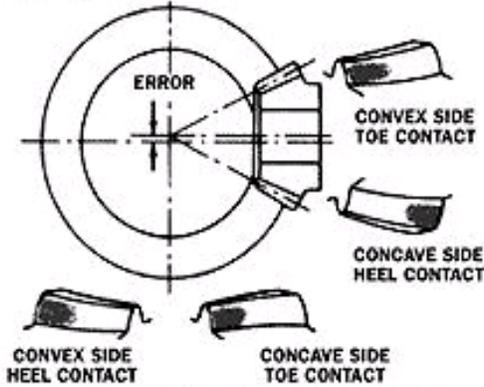
CROSS CONTACT

To correct: move pinion down

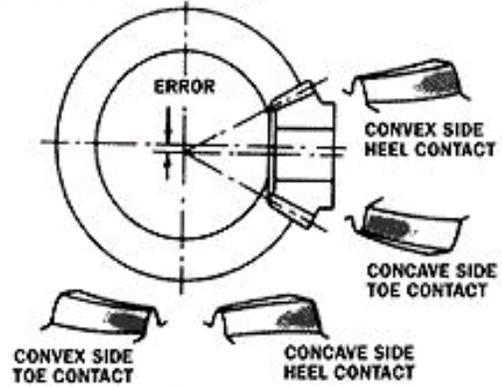
CROSS CONTACT

To correct: move pinion up

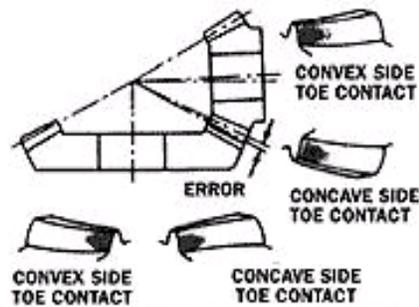
SHAFT ANGLE ERROR

To correct: decrease shaft angle

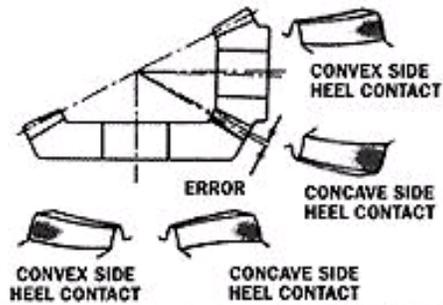
SHAFT ANGLE ERROR

To correct: increase shaft angle
